TRAILER, CARGO: 1/4-ton, 2-wheel, XM416E1

REPORT NO. DPS-224

TEST OF TRAILER, CARGO: 1/4-ton, 2-wheel,
XM416E1

Dates of Test: 12 January to 31 March 1961

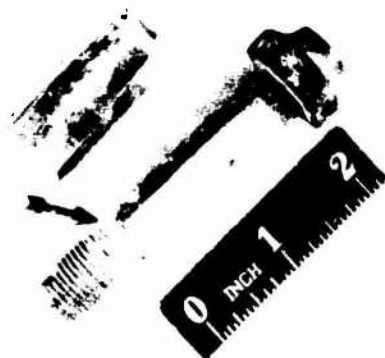
Figure 2: Wear of Left Spring Pivot Bolt and Bushing in 3617 Test Miles.

Synopsis: At odometer 2065, it appeared that the spring pivot bolts were worn. At odometer 3617, the pivot bolts were removed and found to be severely worn. The pivot bolt bushings were also worn.

Cause: During this period, 1363 miles were off road operation. The courses were muddy. Although pivot pins were lubricated frequently mud entered the bearings and accelerated wear.

Action: The pivot bolts and bearings were replaced.
